**STS-108**  
**FLIGHT READINESS REVIEW**

**November 15, 2001**

**Ground Operations**

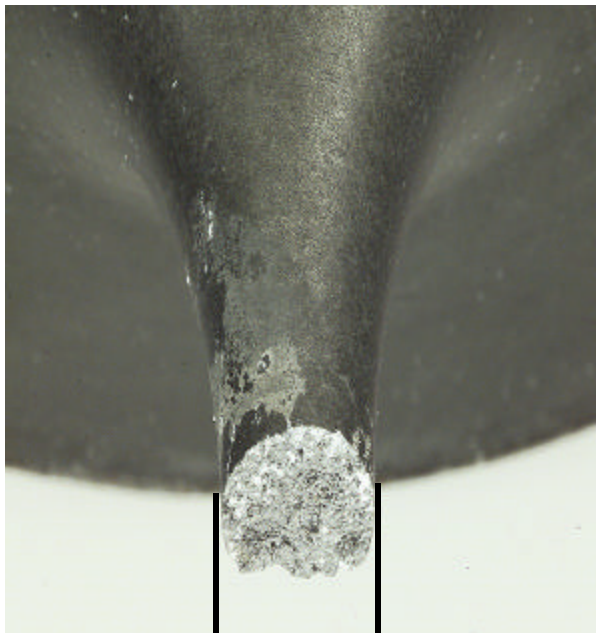
- Observation
  - Following OV-103 STS-105 Launch, inspections discovered a portion of the ET's Ground GH2 vent QD poppet stem broke off
- Concerns
  - Integrity of Ground QD poppet currently installed to support STS-108/ET-111
- Discussion
  - ET's Ground GH2 Vent QD
    - QD component of ET Ground Umbilical Carrier Assembly (GUCA)
    - Allows venting of ET's LH2 Tank to facility
    - QD poppet held open while GUCA is mated to ET
    - At Launch, GUCA disconnects and QD poppet closes to prevent GH2 backflow from vent line and possible ignition

→ 1/2 IN ←

- Actions Taken
  - Analysis determined the poppet fracture was a result of a single instantaneous failure mode
    - Brittle overload event
    - Side load estimated at 230 in-lbs ambient or 330 in-lbs under cryogenic conditions
    - Unable to locate missing piece at Pad-A
  - Discrepant QD poppet was used for 16 launch cycles
    - 16 launch cycles was the fleet leader
    - Poppets are certified for 55 launch cycles
  - STS-108 QD was suspect based on material usage
    - Unit had 13 launch cycles
    - Lack of specific pre-installation inspection for surface flaws

- Most Probable Cause
  - Failure result of T-0 separation event
    - Combination of material degradation of poppet and undetected surface defect on the ground/flight contact surface made the poppet more susceptible to shear failure during the friction inducing sideload event
- Flight Rationale
  - Installation of new ET Ground GH2 QD on STS-108 removes the “most probable cause “ scenario
    - Passed specific ground/flight interface inspection
    - Zero cycle usage for newly installed poppet
- Risk Assessment
  - As a result of new poppet with zero launch cycles and detailed inspection, reoccurrence of this anomaly is remote

- Actions Taken (Cont'd)
  - New redesigned GH2 Vent QD was installed on ET-111
    - New QD has zero launch cycles
    - Ground and Flight interfaces were verified free of defects
      - More detailed inspection process
  - Vendor material analysis is inconclusive as to root cause of STS-105 QD poppet fracture
    - Possible higher material porosity than normal but within manufacturing specifications

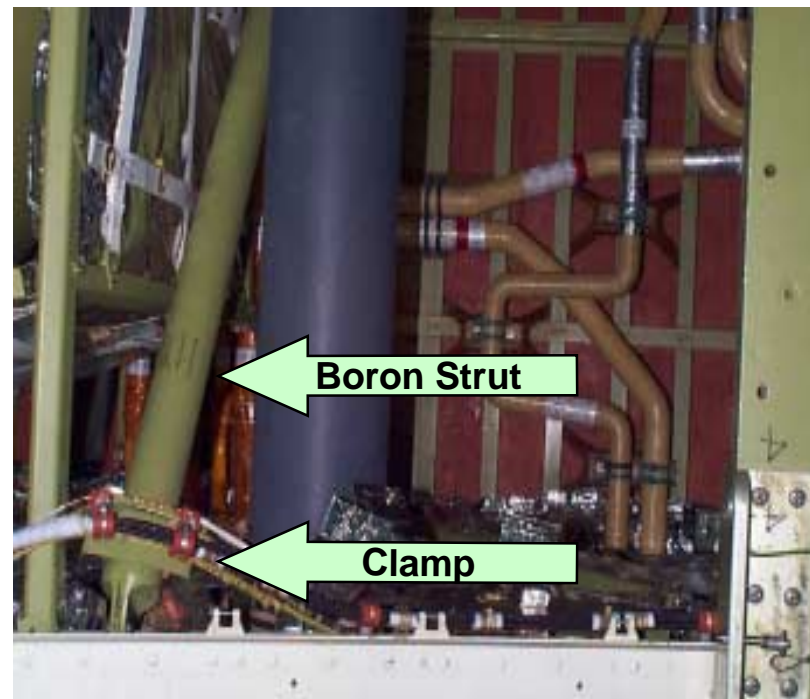
Typical Clamp Installation

- Observation
  - OV-103 Boron Strut was found damaged in Mid Bay 7 at the location of a wire clamp
  - Three additional locations found where clamp was on boron portion of the strut
    - One on OV-102, One on OV-103, One on OV-104
- Concerns
  - Compromised Boron Strut Capability (Generic Problem)
- Actions Taken
  - Review of Clamp Installation Procedures
    - OMI that installed OV-103 clamp is unclear and may have contributed to mis-locating the clamp
  - Partial inspection of OV-102, OV-103 and OV-104

- Actions Planned
  - Continue inspections on OV-102, 103, & 104
    - Goal is 100% inspection
  - Review installation paper for the 3 discrepant locations
  - Inspect accessible locations on OV-105
    - Bay 6 and 7 via the PLAP (Payload Late Access Platform)
  - Identify clamp installations on OV-105 via drawing review
  - Exonerate clamp installations via inspection, close-out photo review, design
  - Perform worst case stress analysis for all others
  - Identify struts with negative margin

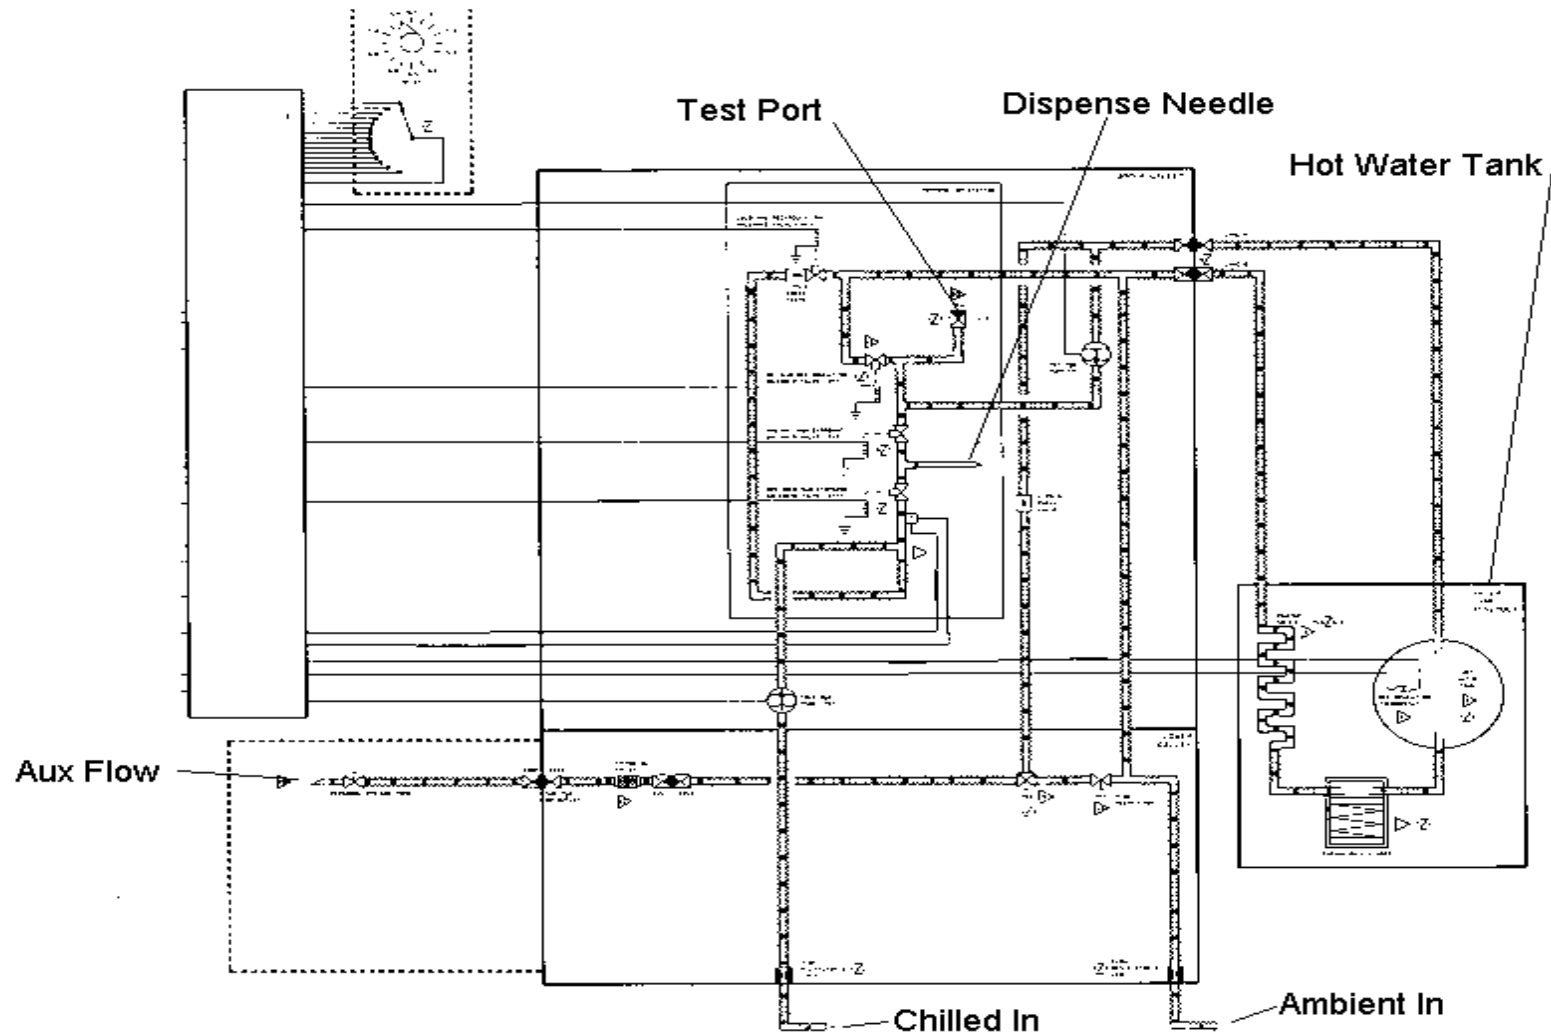
GO BU-5

- Observation
  - Galley flowrates from the hot and cold needles degraded during 8 ounce dispenses (allowable is 210 to 251 mL)
    - Cold dispense quantities – 220, 210, **180**, **80** mL
    - Hot dispense quantities – **110**, **110**, **60** mL
  - Auxiliary H2O port experienced degraded flow
    - Provides water for personal hygiene
  - Problem occurred October 10, 2001
- Concerns
  - Affect In-Flight drink and bag fill operations
  - Use of alternate water collection points if dispense function failed

- Possible Causes
  - Free air could cause intermittent flow reduction by affecting water pump performance
    - Orbiter system was evacuated and backfilled with water
      - Required vacuum of 25 mmHg was not obtained (actual 44 mmHg)
    - Post evaluation discovered air leak on GSE jumper assembly
  - Flow restriction/contamination could degrade flow
    - Both hot and cold Galley needle dispense flowrates affected
      - Common source is on Orbiter side between Tank A and Galley Supply valve tee
    - No intrusive work performed on Orbiter water system this flow
      - Galley hot water tank replaced

- Most Probable Cause
  - Free air in the system
